Invisible crystals and regulator failures

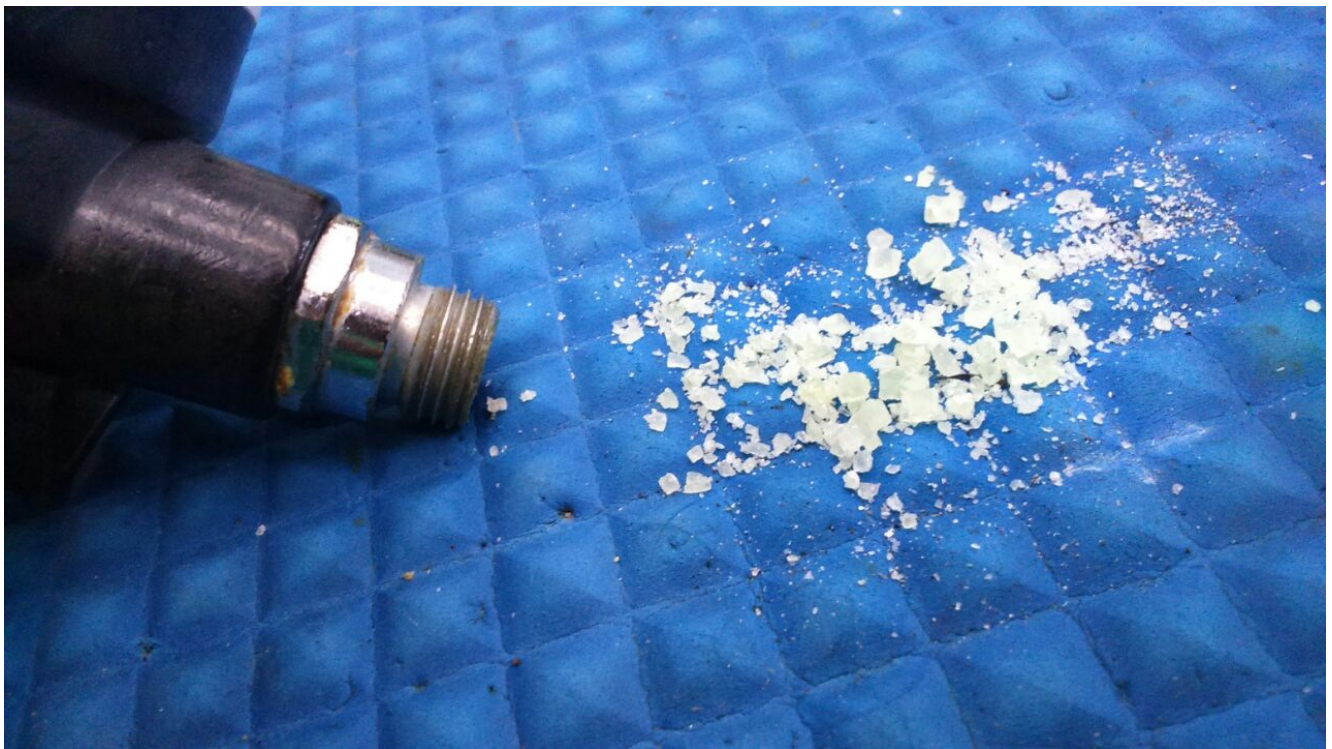
Although the diver involved in the incident managed the situation very well, and no one was harmed, an inexperienced or nervous diver might not have been so fortunate. It was particularly strange that although the diver's cylinder was not empty, the gas flow had slowed and then ceased in a way that resembled an out-of-air situation. Closer examination of the equipment led to a puzzling discovery: a large amount of yellow 'crystallized' material was blocking the inside of the second-stage regulator inlet. The material appears to originate from within the hose, which had been in use for a few years but showed no external abnormalities or signs of deterioration.

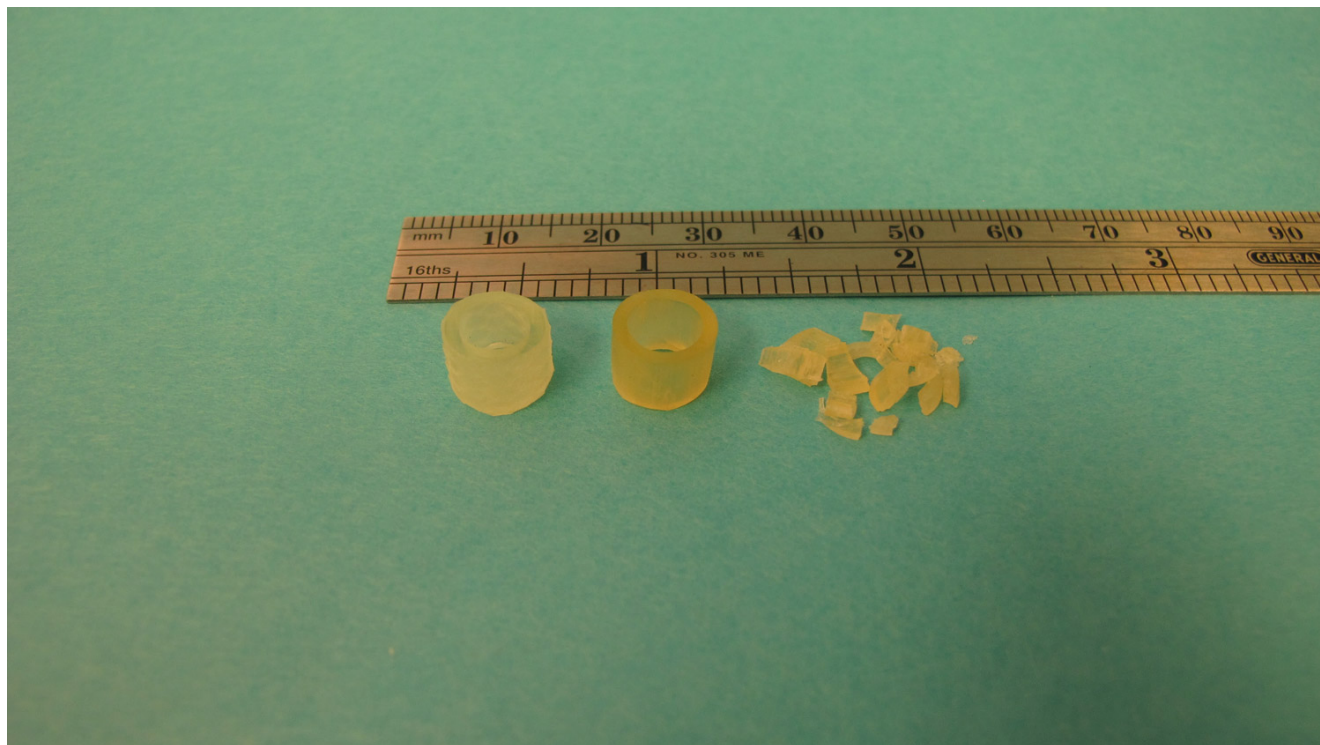
One avid diver, a specialist engineer at a private company in USA, offered to perform a thorough testing of low-pressure braided scuba hoses. He subjected a variety of hoses to accelerated aging, and the preliminary finding was that hoses with a thermoplastic *polyester-polyurethane* (polyester-TPU) lining

material decayed during testing. This result is consistent with the hose-failure reports DAN has collected. Hoses made of or lined with thermoplastic *polyether*-polyurethane (polyether-TPU), on the other hand, did not fail.

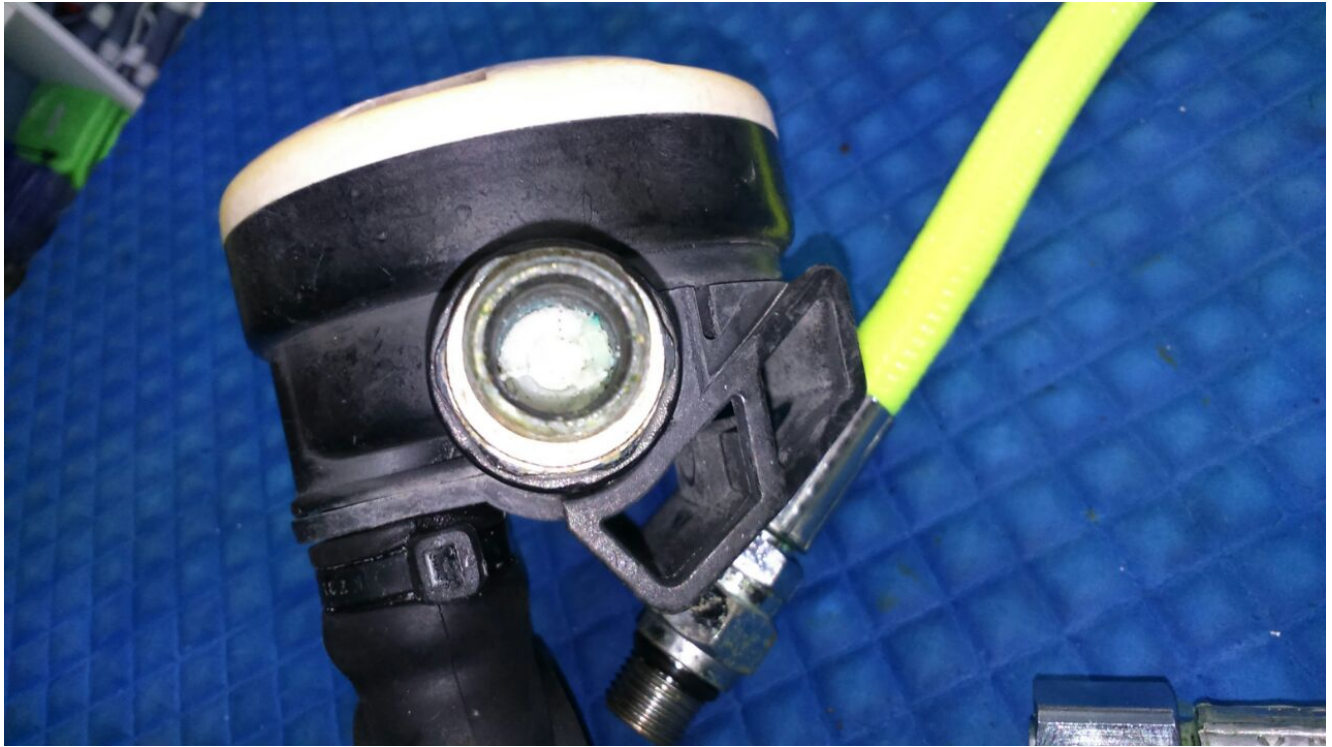
The standard safety recommendation regarding regulator hoses has been that they should be inspected regularly for signs of external deterioration. Disintegration or abrasion of the outer rubber coating eventually predisposes hoses to rupture during pressurization or even when in use. Rubber hoses are quite prone to this condition, which is why polymer-braided hoses were developed. But herein lies the problem: The outside of braided hoses can appear normal, flexible and free from obvious abnormalities, while a deteriorated internal surface would be completely invisible to a cursory external inspection.
