Invisible crystals and regulator failures

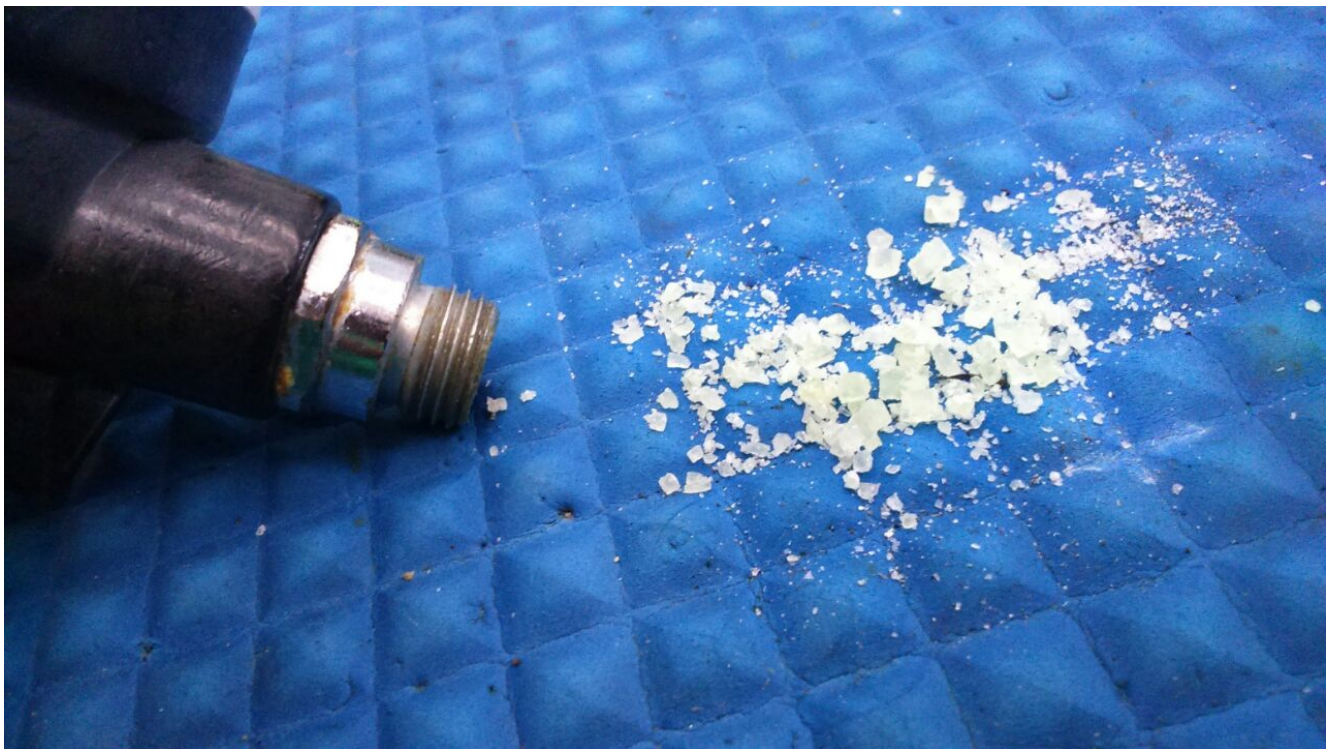
Although the diver involved in the incident managed the situation very well, and no one was harmed, an inexperienced or nervous diver might not have been so fortunate. It was particularly strange that although the diver's cylinder was not empty, the gas flow had slowed and then ceased in a way that resembled an out-of-air situation. Closer examination of the equipment led to a puzzling discovery: a large amount of yellow 'crystallized' material was blocking the inside of the second-stage regulator inlet. The material appears to originate from within the hose, which had been in use for a few years but showed no external abnormalities or signs of deterioration.
