Invisible crystals and regulator failures

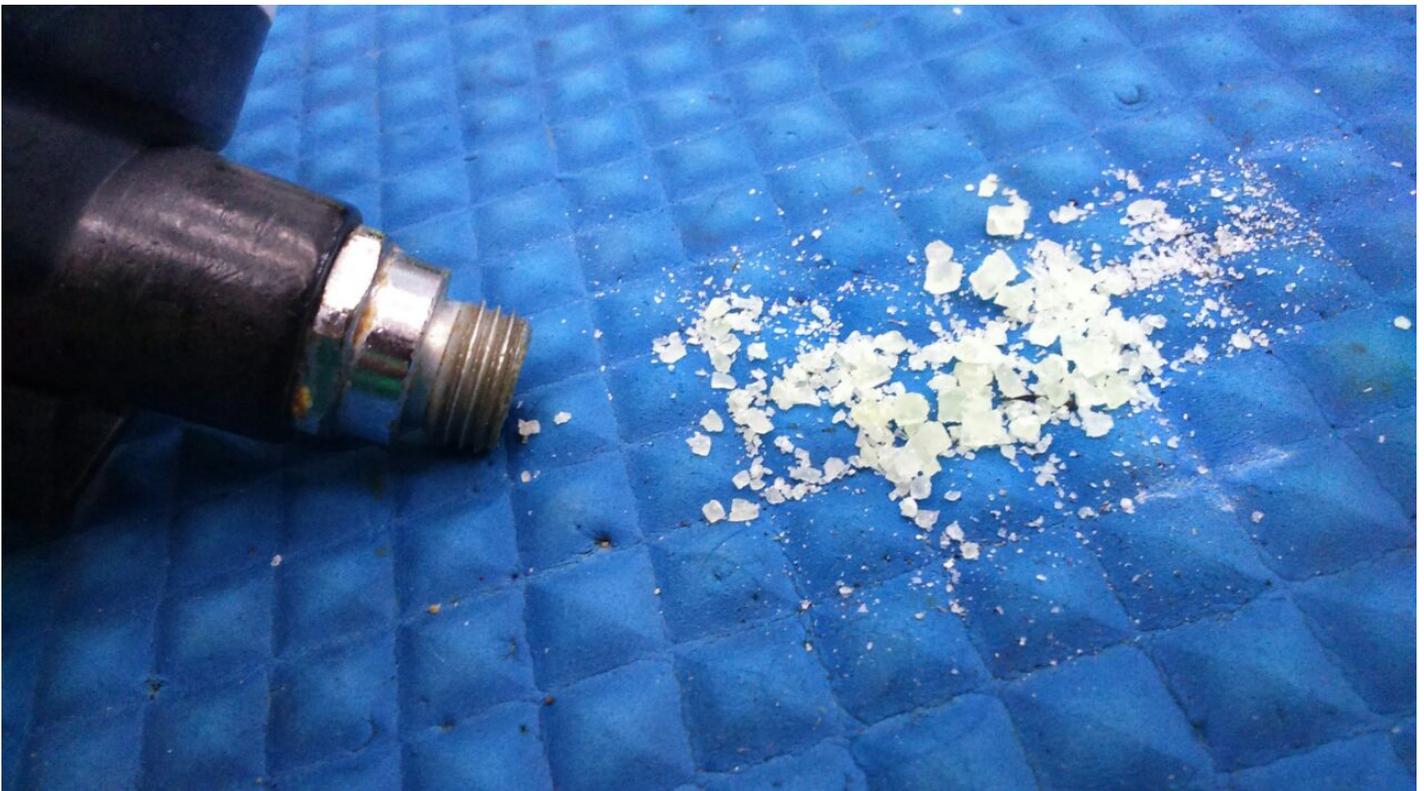
Although the diver involved in the incident managed the situation very well, and no one was harmed, an inexperienced or nervous diver might not have been so fortunate. It was particularly strange that although the diver's cylinder was not empty, the gas flow had slowed and then ceased in a way that resembled an out-of-air situation. Closer examination of the equipment led to a puzzling discovery: a large amount of yellow 'crystallized' material was blocking the inside of the second-stage regulator inlet. The material appears to originate from within the hose, which had been in use for a few years but showed no external abnormalities or signs of deterioration.

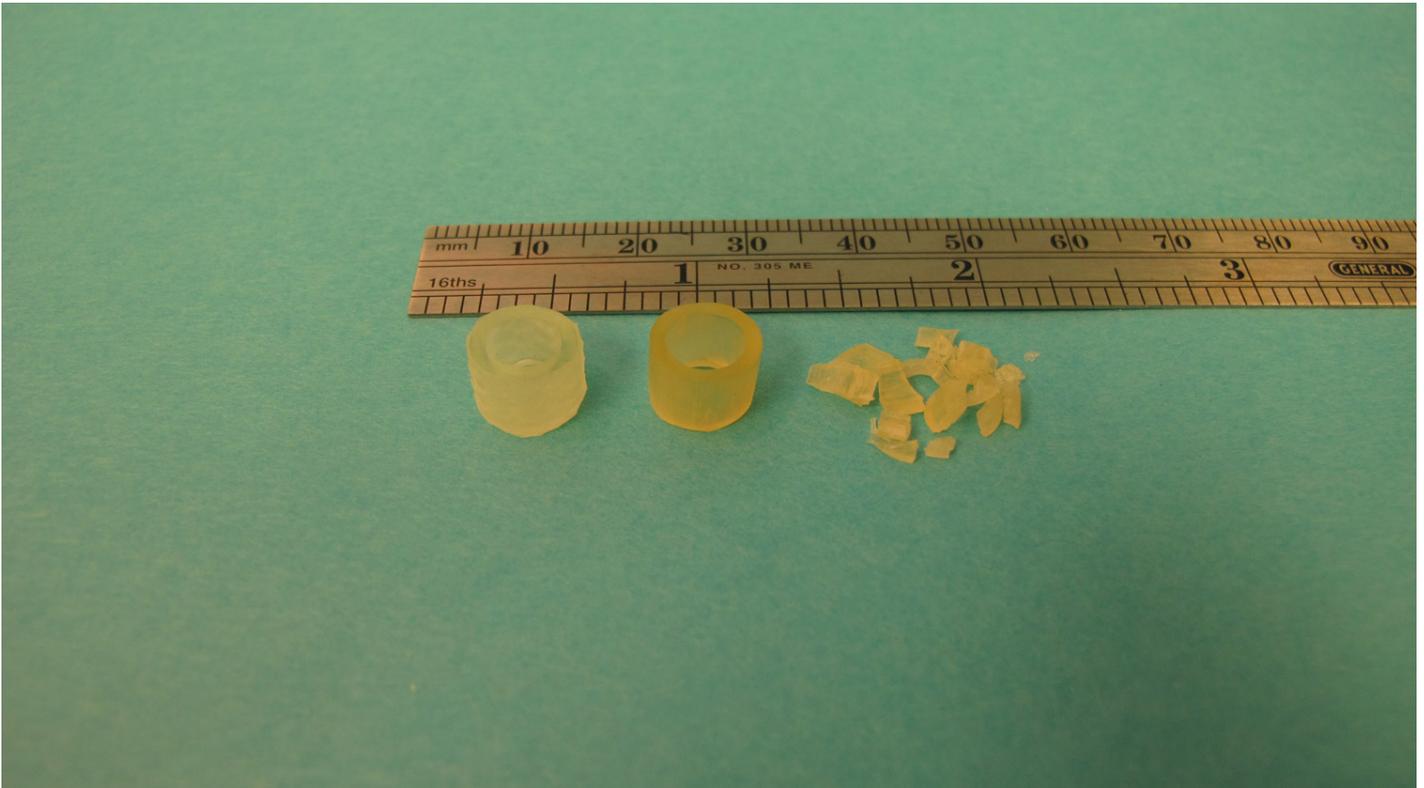
One avid diver, a specialist engineer at a private company in USA, offered to perform a thorough testing of low-pressure braided scuba hoses. He subjected a variety of hoses to accelerated aging, and the preliminary finding was that hoses with a thermoplastic *polyester*-polyurethane (polyester-TPU) lining material decayed during testing. This result is consistent with the hose-failure reports DAN has collected. Hoses made of or lined with thermoplastic *polyether*-polyurethane (polyether-TPU), on the other hand, did not fail.

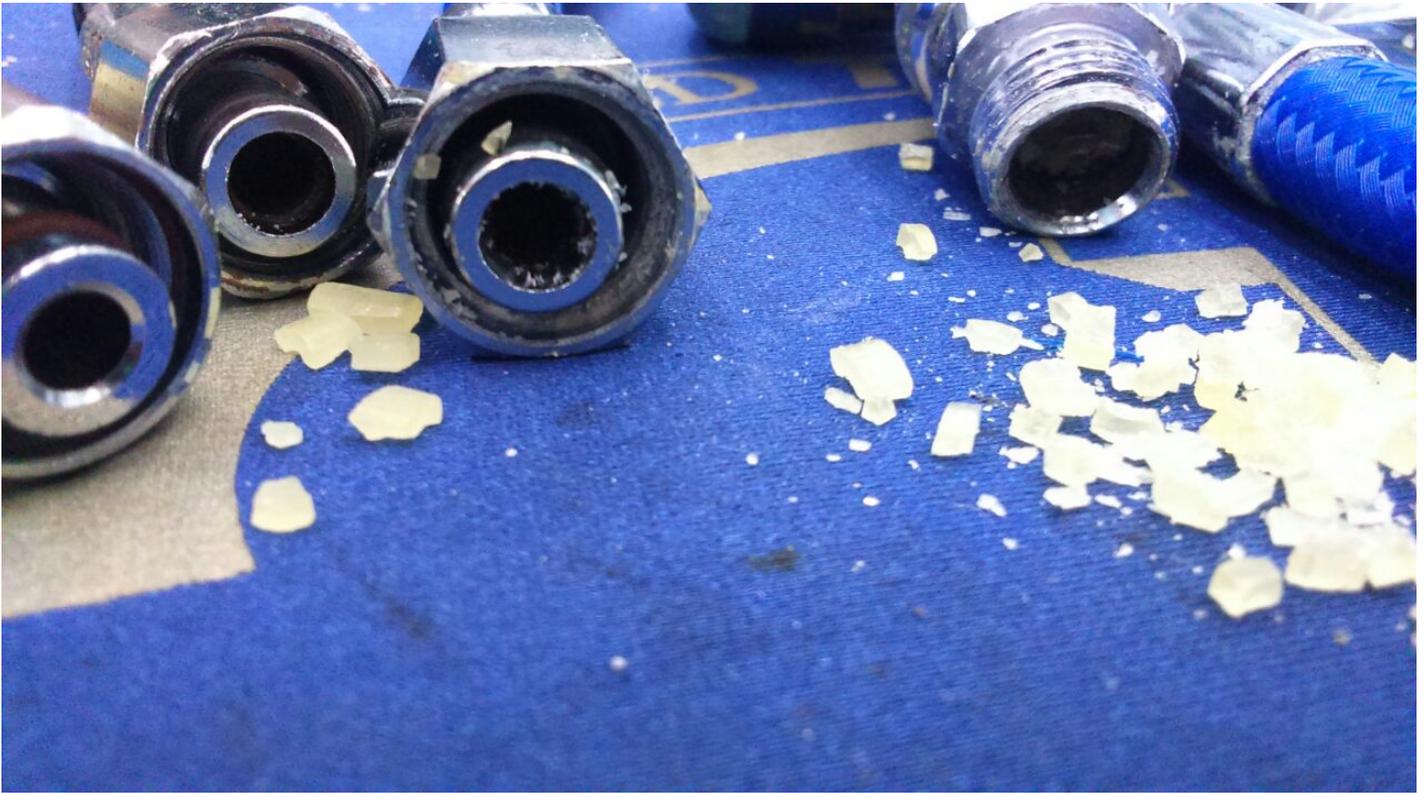
The decay product, a yellow crystalline-looking substance, is softer than it appears and feels waxy when squeezed. The reaction causing decay is actually hydrolysis, which, as its name implies, requires the presence of water. Elevated temperature promotes accelerated degradation or hydrolysis of the polyester-TPU. Repeated cyclical heating and cooling of the hose lining promotes this form of crystallization in materials either unsuitable for this application or affected by certain chemicals or bacteria. The sun heats the hose, then the flow of breathing gas cools down the internal surface of the hose again. This process recurs with each dive, and the 'crystals' accumulate over time. Enough 'crystals' eventually form to encroach on the gas flow, or they migrate toward the second-stage regulator, resulting in significant failure of the breathing device.

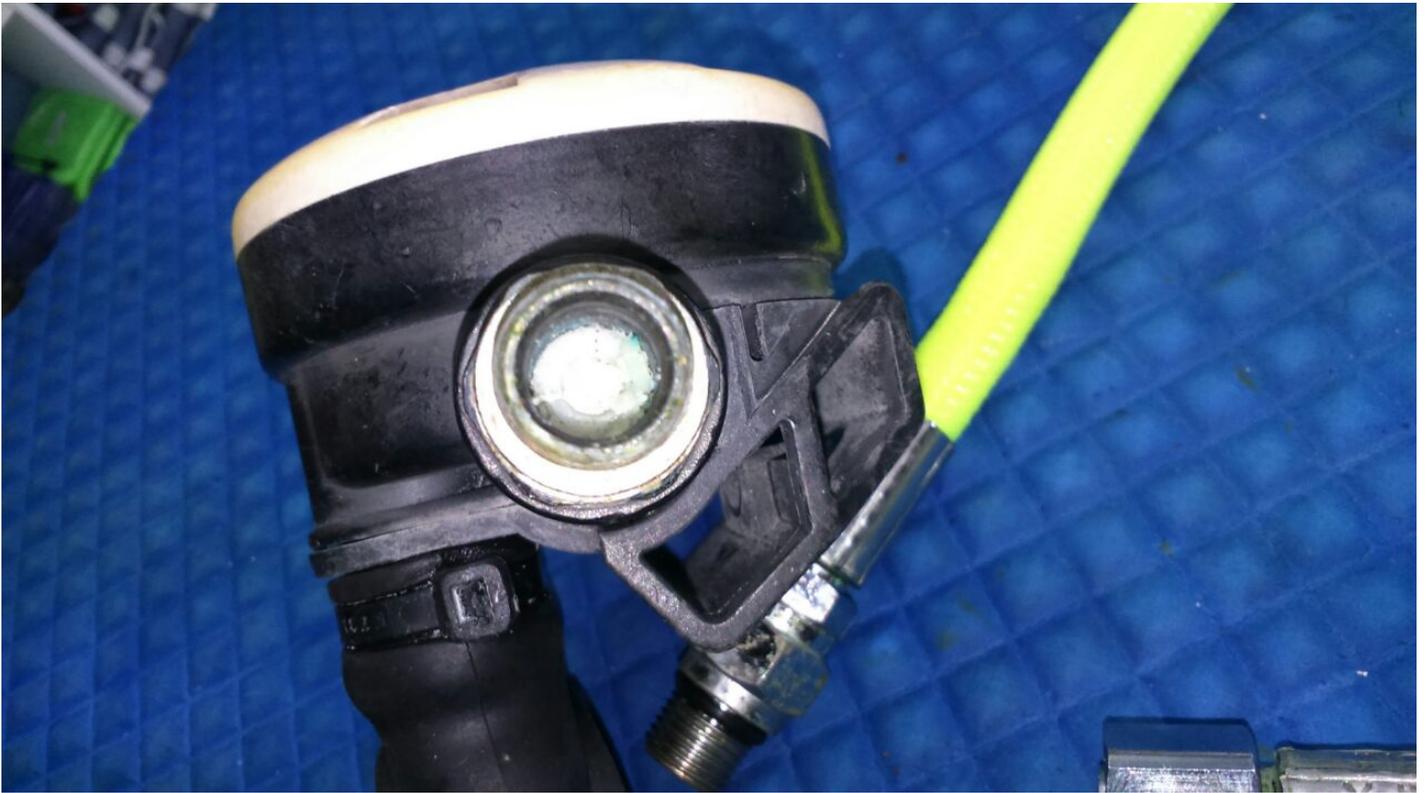
The standard safety recommendation regarding regulator hoses has been that they should be inspected regularly for signs of external deterioration. Disintegration or abrasion of the outer rubber coating eventually predisposes hoses to rupture during pressurization or even when in use. Rubber hoses are quite prone to this condition, which is why polymer-braided hoses were developed. But herein lies the problem: The outside of braided hoses can appear normal, flexible and free from obvious abnormalities, while a deteriorated internal surface would be completely invisible to a cursory external inspection.
